Notification for KS32C50100 Design Bugs

2 February, 2000
(Ver 4.0)

Samsung Electronics Co., Ltd.

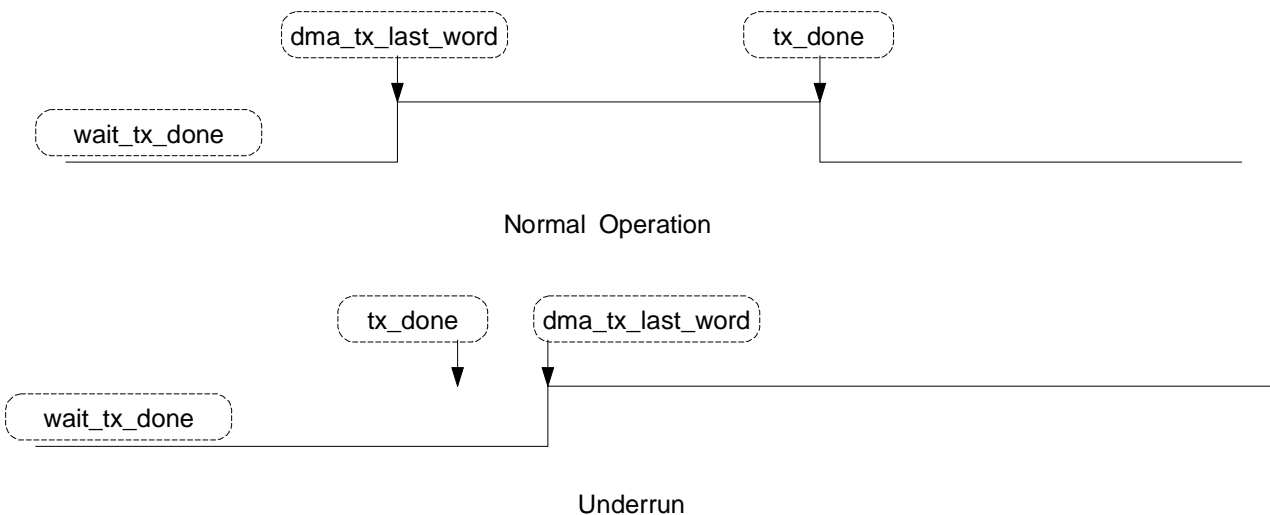
During the HDLC Tx mode (especially for more than 10Mbps data rates), when Tx underrun occurs, very rarely Tx mode hangs and data transmit will be stopped. HDLC DMA hang can be released by resetting the DMA Tx.

The wait_tx_done signal in DMA Tx module will be set to "1" when DMA completes moving data into TxFIFO. It will be cleared to "0" when tx_done signal, which tells the completion of data transfer into TxFIFO, is asserted from XMTR. DMA will check the level of wait_tx_done and when it is "0", DMA will assert BUS Request to move data into TxFIFO.

Generally, if a frame has transmitted successfully, dma_tx_last_word signal is asserted earlier than tx_done signal. And then wait_tx_done is set to "1" and returns to "0".

But if Underrun happens, tx_done signal is asserted. When it happens, tx_done is asserted at 1 cycle earlier than dma_tx_last_word. As a result, wait_tx_done isn't set to "0", at all. Therefore, DMA Tx does not ask Bus Request for data transmission and system is hanged eventually.

KS32C50300 will be revised to resolve the problem. For the current devices, there are two software turn around solutions.

1) Software Turn Around 1

In the interrupt service routine, whenever Tx Underrun happens, turn OFF and ON MFF in HMODE. It will not degrade system performance and can fix the bug.

2) Software Turn Around 2

In the interrupt service routine, whenever Tx Underrun happens, turn ON TxABT in HCON. It will not degrade system performance.
