TECHNICAL SERVICE REPORT

SUBMITTED BY: RUSSELL W. PETERS

DATE: AUGUST 4, 1975

SUBJECT: HORNS

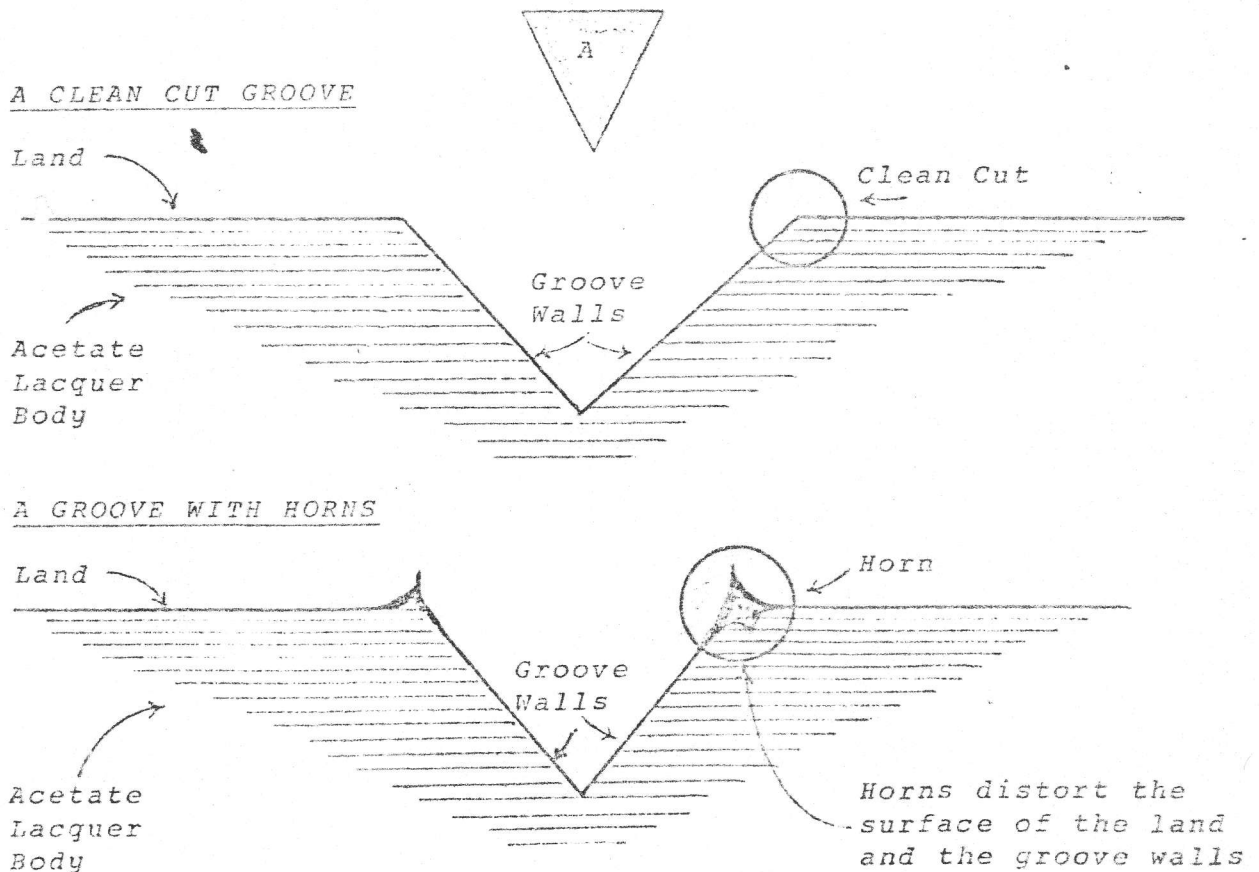
*Exaggerated Drawing

Horns originate during the cutting of an acetate lacquer. They are made from the pressure exerted by the cutting stylus against the acetate lacquer as it ploughs through the material cutting out the groove. The horns are a ridge or shoulder, formed on the top edges of the groove that vary in size from insignificant to paramount. (See Illustration A.*)

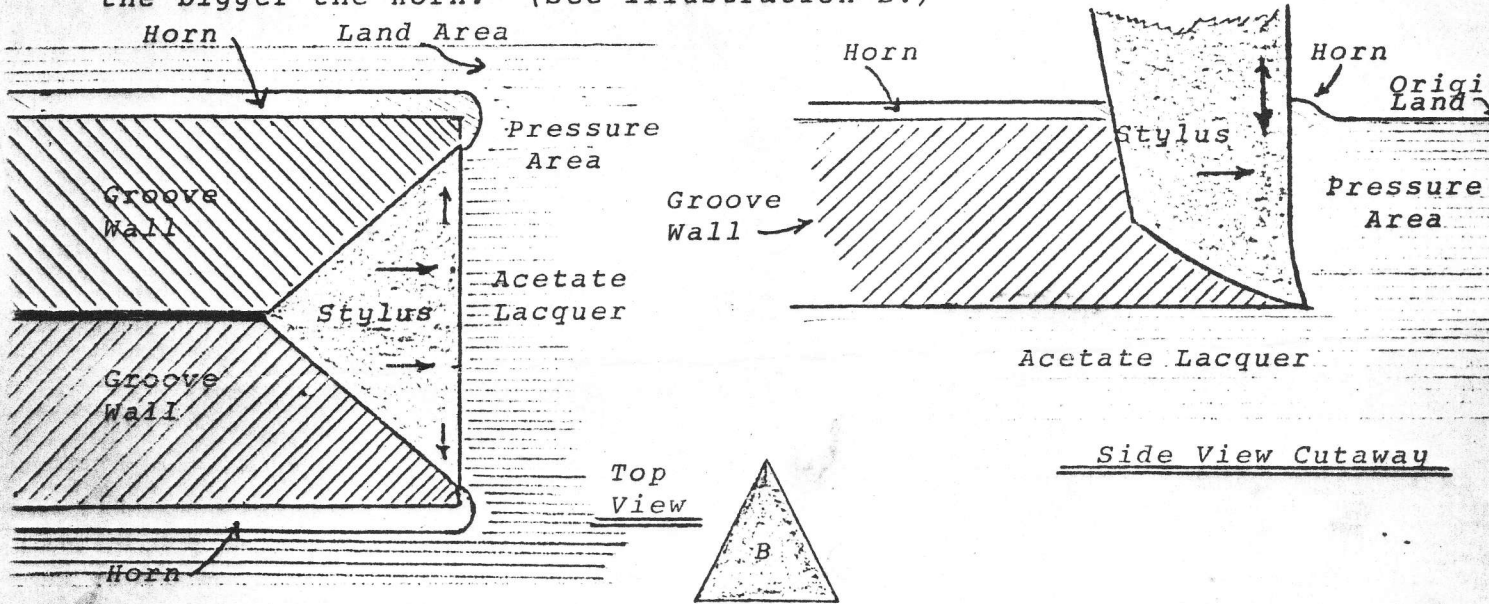
The deeper the groove, the wider the groove, the higher the pressure, the bigger the Horn. (See Illustration B.)

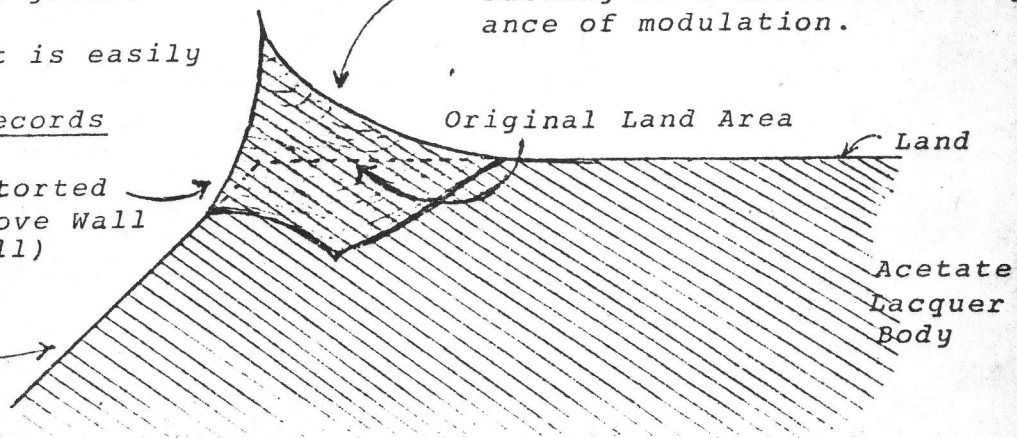
Groove Wall
 Exaggerated Drawing

A horn is also the continuation and part of the groove wall. It is distorted in shape (relative to the wall) and its size is proportional to the pressure exerted against the acetate by the cutting stylus. This distorted part of the wall is caused by the acetate cold flow and/or memory. It starts happening immediately behind the cutting stylus as it cuts through. The horn that has just been formed is at a higher internal pressure area from the plough-pressure effect of the stylus. It is warmer than the other material from the pressure, friction, and stylus thermal heat, so it is softer. These factors help the horn to try and flow back to its original place (that it was pushed from) so, at the top of the groove wall the wall actually sags inwardly. (See Illustration C.)

1. Part of the groove wall.
2. Carries modulation like the groove wall.
3. Is distorted from the groove wall.
4. Has a thin point that is easily bent.

1. Sound Loss
2. Distortion
3. Surface Noise
4. Silver Lines (Non Fill) on Groove Left Side.

The acetate in this area is more dense and compacted, resulting in a different acceptance of modulation.

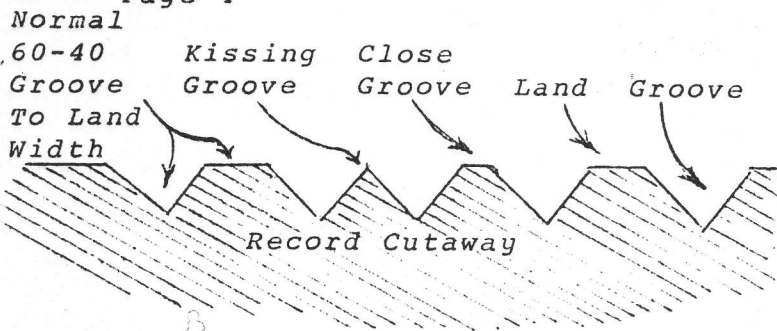
5. A Cold Stylus - increases the pressure against the acetate, forcing the top edges of the groove to Horns and also causes groove edge chipping.
6. Kissing and Close Grooves - When grooves come too close together, they actually eliminate the original land area by overlapping the shoulders or horns of each groove. This buildup superimposes the land area, making the groove deeper than it actually is (in comparison to the original land) and accepting modulation to the top of it. The closer the grooves, the higher the horn until the grooves actually touch at the top where the original land was. This is a "kissing groove," and probably the worst offender of all because the modulation was imposed all the way up the horn side. When the stylus made the "kiss," it cut and pushed its way through the horn from the 1st groove, cutting a super high and pointed horn that is pushed over towards the 1st groove - (outside of record direction). Because of the extra heat from friction and the thinness of this horn, it tends to curl over the 1st groove. See Illustration "D."

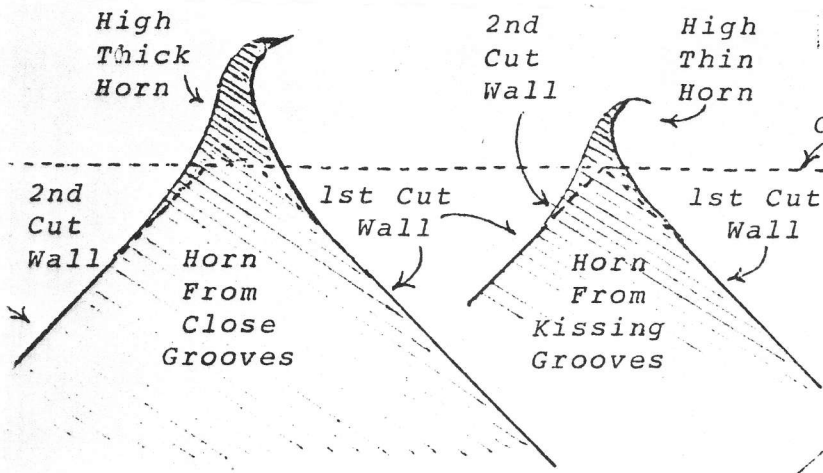
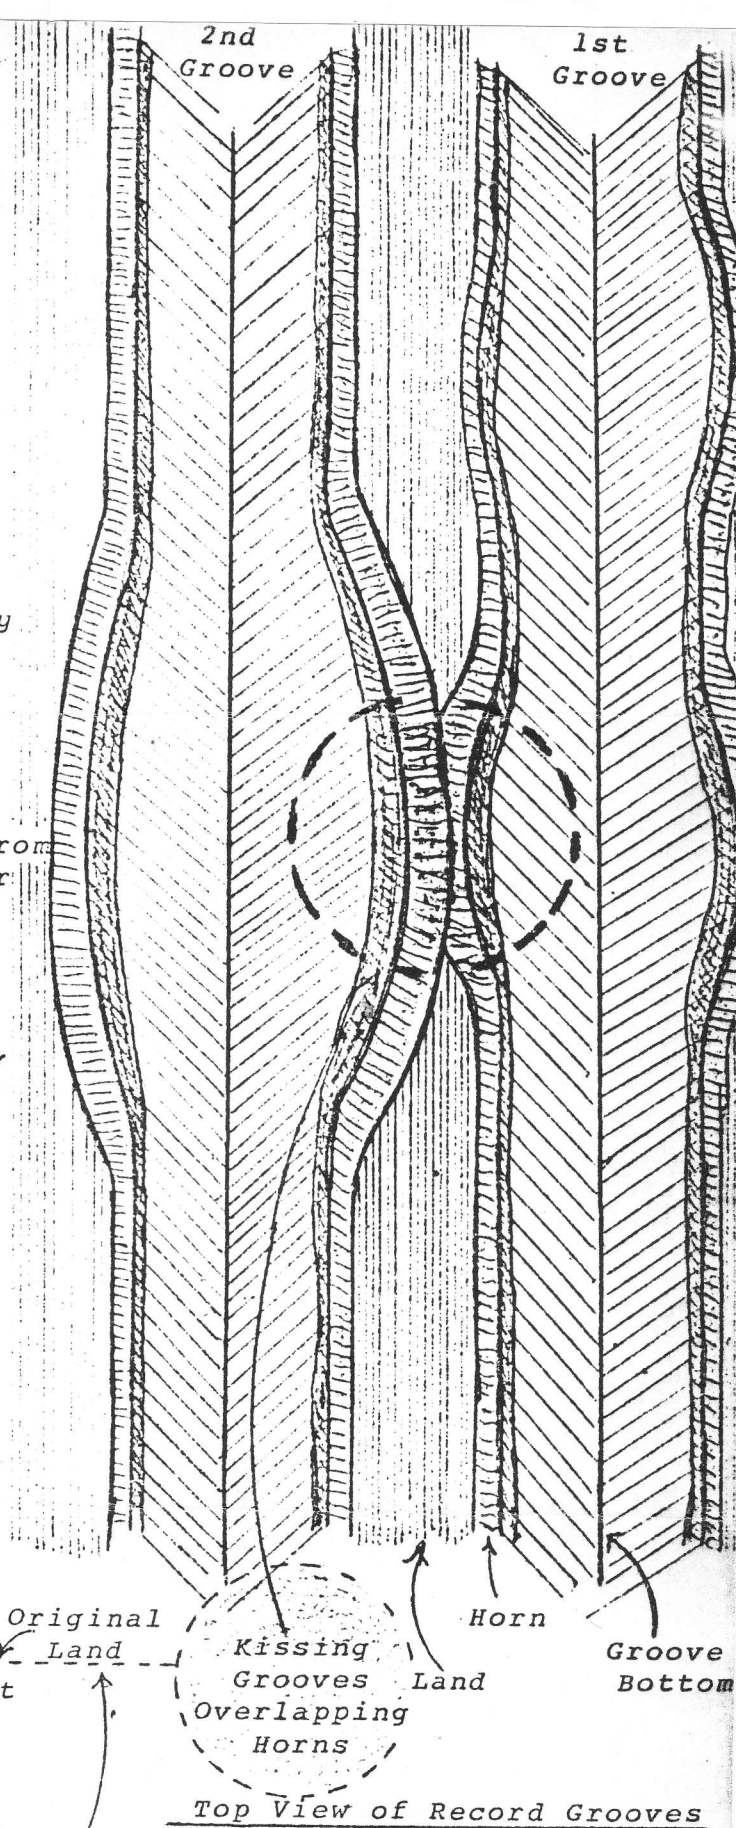
Kissing and Close Grooves

The top of the double horn actually curls like an ocean wave, making a hollow in the stamper that is extremely difficult to fill with compound when pressing the record. This type of horn results in a loud, unacceptable noise and can be seen when looking at a record from the outside edge towards the center on a horizontal plane as silver lines, stitching, or white lines - all meaning un-fill. (See Illustration E.)

When the land area between grooves is reduced to where the Horns touch, pressing problems increase in proportion to the horn overlap.

otted lines show where the land would be with a proper cut.

When stampers are formed from masters with small, or no land areas (Big Horns), the deep crevasses formed in the stamper are not only hard to fill with compound but, when they do fill, the compound in the horn is overheated. This is because of the large surface heating area in relationship to the amount of material, and the additional amount of external friction heat generated when the compound is forced into the horn. This excess heat breaks down the stabilizer properties in the compound and so the compound degrades, and the stabilizer separates from the compound and bleeds out. The bleed-out accumulates on the stamper and causes more un-fill in the record, which is part of the silver lines noise. See Illustration "E".

When records were being pressed six or seven years ago, the biggest single complaint was non-fill. Keysor-Century developed a fast-flow compound that virtually eliminated this problem when pressing parameters are within reason. When the problem of silver lines (or stitching, or white lines) occurs, this un-fill phenomena is never completely solved. The compound is usually blamed for the problem, and rightly so, because the compound is not properly filling the record. The flow of the compound is at fault and even though it can be changed by formulation, heat, pressure, cycle time or a combination of these things, a severe horn problem is seldom solved by adjusting the compound flow properties. See Illustration "E".

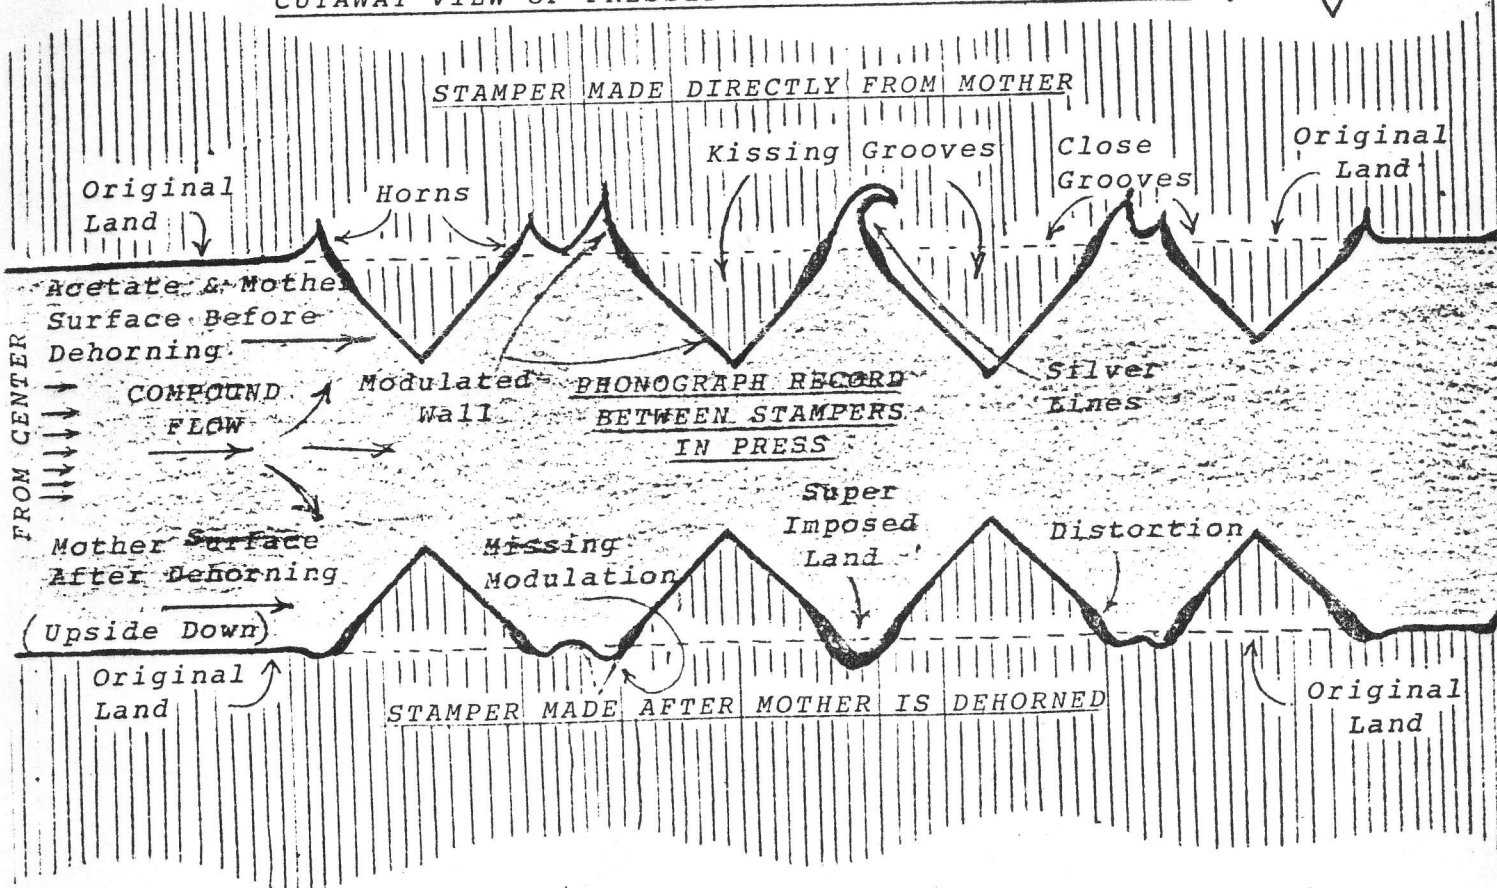
CUTAWAY VIEW OF PRESSED RECORD BETWEEN STAMPERS

After the acetate master has been cut, it is prepared, silvered, preplated, and/or plated to produce a nickel stamper or unconverted master. From this step, the stamper may be placed in the press, and using the normal phonograph record pressing plant system, records can be pressed. Otherwise, the unconverted master may be treated and replated to produce a "mother" the exact duplicate of the acetate master in nickel, instead of plastic. The Horns, unchanged and as impressive as before, are now made of nickel. Except, where the horns on the acetate were extremely large and curly, the chances of reproducing them perfectly is remote because the horn configuration is located in the bottom of the stamper grooves, so plating those minute crevasses in detail is remote. To make the odds of failure even better, when the stamper-mother is separated, if a long deep horn was formed properly it then breaks off and stays in the bottom of the stamper or falls out. So, weak areas are formed in the top of the groove walls, which later result in damaged grooves and noise on the stamper made from the mother. This particular problem usually is discovered after some records have been pressed where the test pressing and even the first part of the run is ok; then, the part fails and the following records are rejects. This problem is usually blamed on contaminated and hard compound, or press operator carelessness.
